### **Mini-Tower test results**

Luca Latronico INFN Pisa for the TKR subsystem

GLAST International Collaboration Meeting Accademia Nazionale dei Lincei Roma 15-18 September 2003

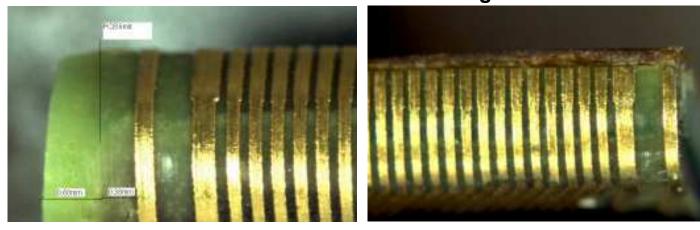
### **Still missing channels for pitch adapter problems**

left side

right side

#### tracks shift

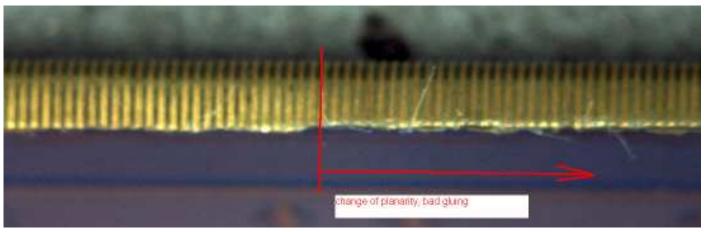
#### **Bad gluing and planarity**

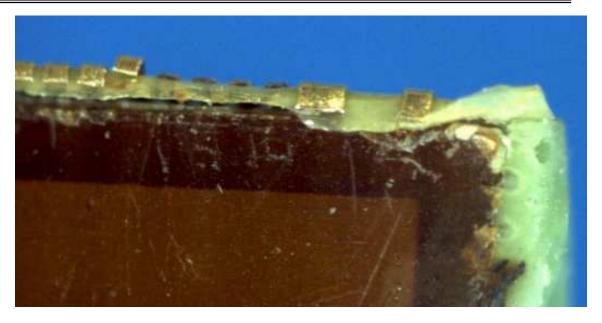
### Still missing channels for pitch adapter problems

The HV, GND and some channels lines are wrapped around the PCB edge, preventing bonding

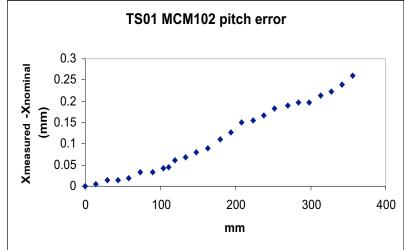
### Wrong pitch

• 191 missing wire-bonds to strips

had to give up redundancy of bias HV connections on border ladders

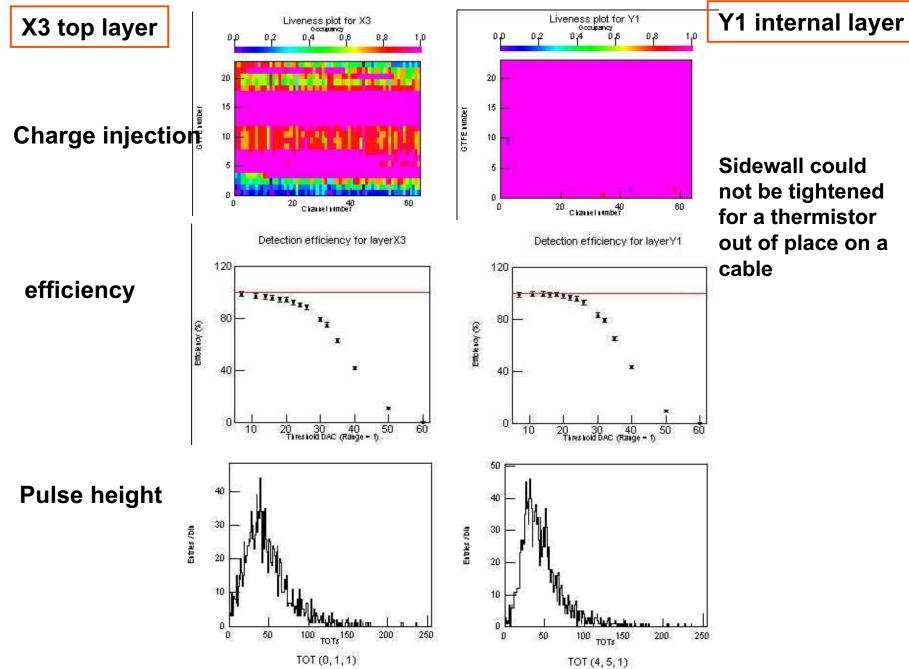
#### Light leak from the top

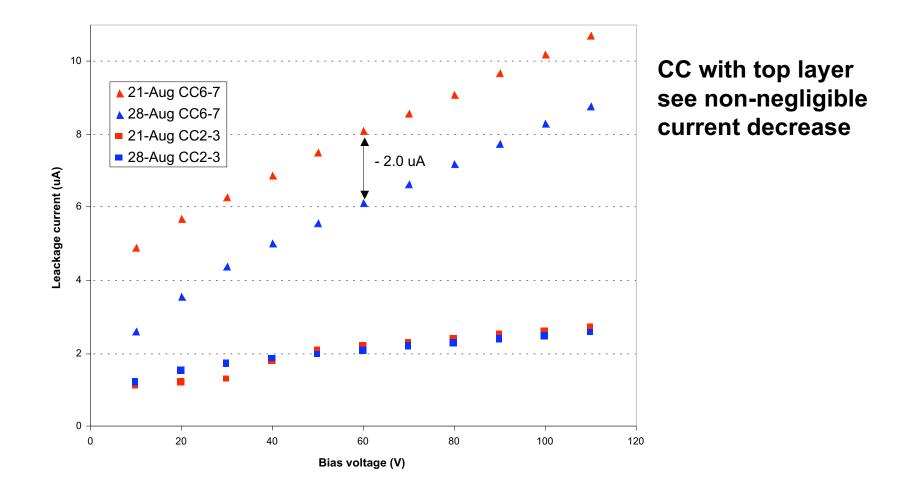
### Light leak and leakage current

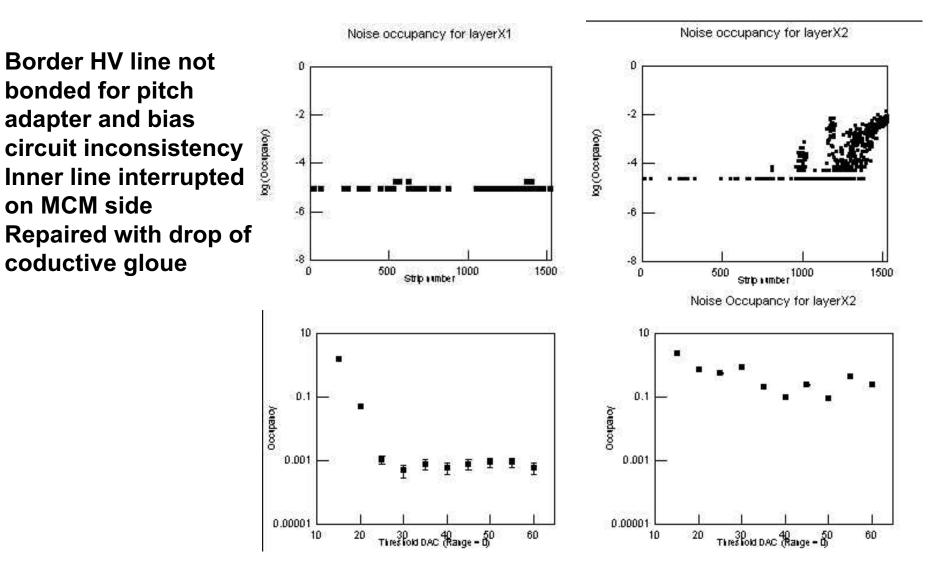
### **Bad HV connection on border ladder**
