EM tower construction and test

Alessandro Brez
INFN Pisa

TKR Engineering Model-Tower

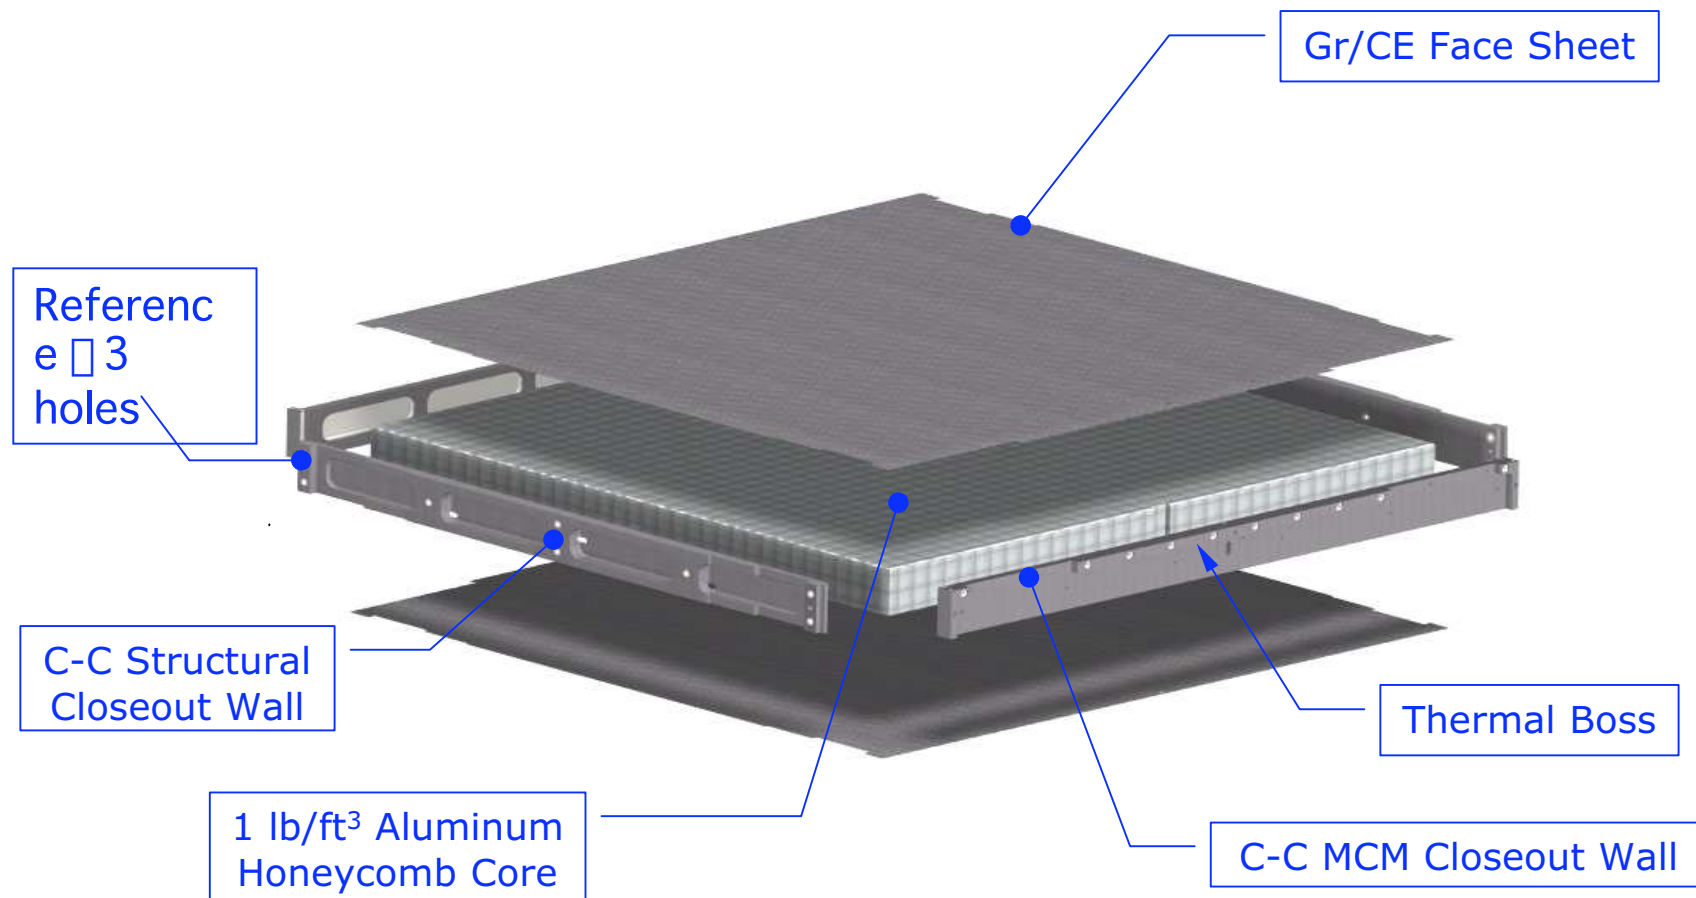
Tray Sandwich Structure

- Lightweight 4 pieces machined closeout frame, bonded to face sheets and core to form a sandwich structure

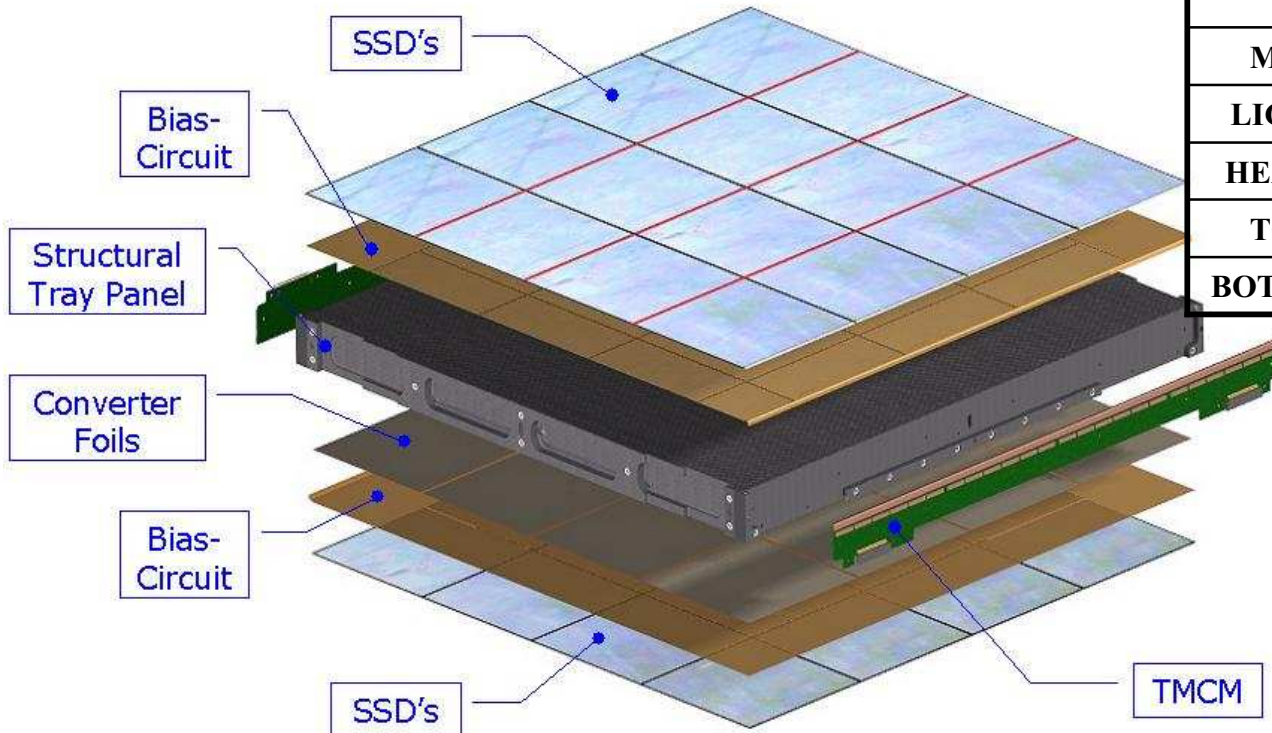
Tracker Tray with Payload

- The tray "payload" is bonded to the sandwich structure using epoxy, with the exception of the SSD bonding, which is done with silicone.
 - Silicone decouples the thermal/mechanical effects from the tray

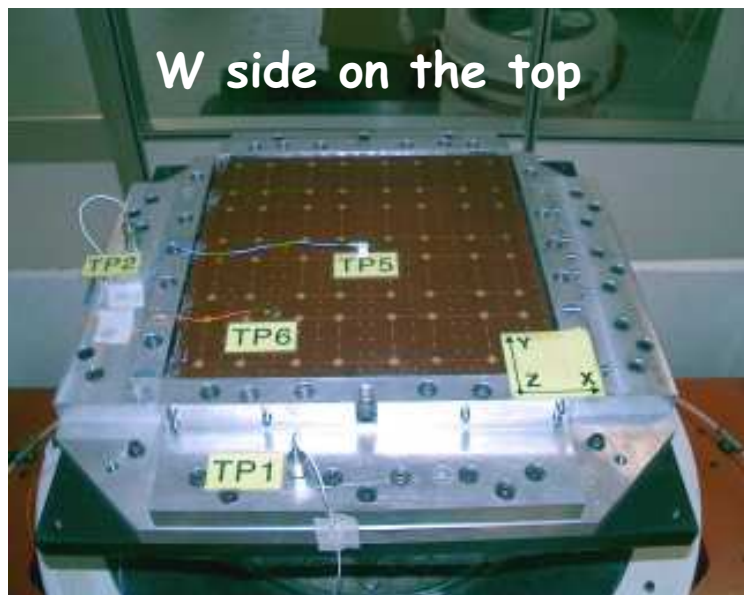
Tray vib set up

Accelerometers position:

- Control: two mono-axial accelerometers positioned on two of the four L-shaped block TP1&TP2
- Fixture: three mono axial accelerometers placed on a corner on one of the four L-shaped block TP6
- Tray: one three-axial accelerometer in the middle TP5

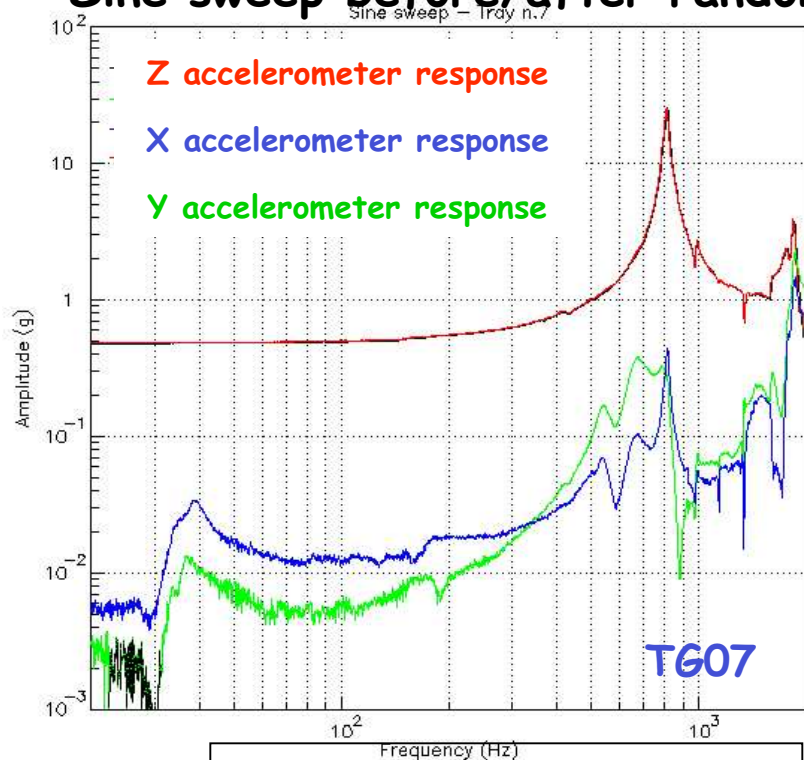
Sine sweep before/after random

Resonance search:
 $\omega_0 = 815 \text{ Hz}, Q = 51$

All the EM trays have been successfully tested at qualification level.
No damages or relevant frequency shifts have been observed

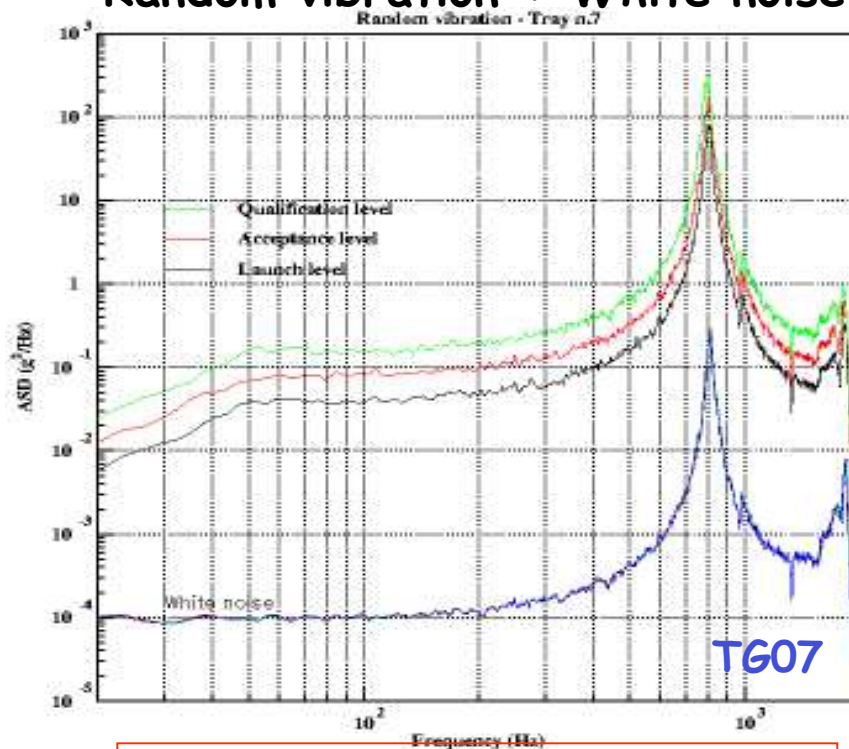
Random vibration + White noise

Resonance check:
 $\omega_0 = 809 \text{ Hz}, Q = 49$

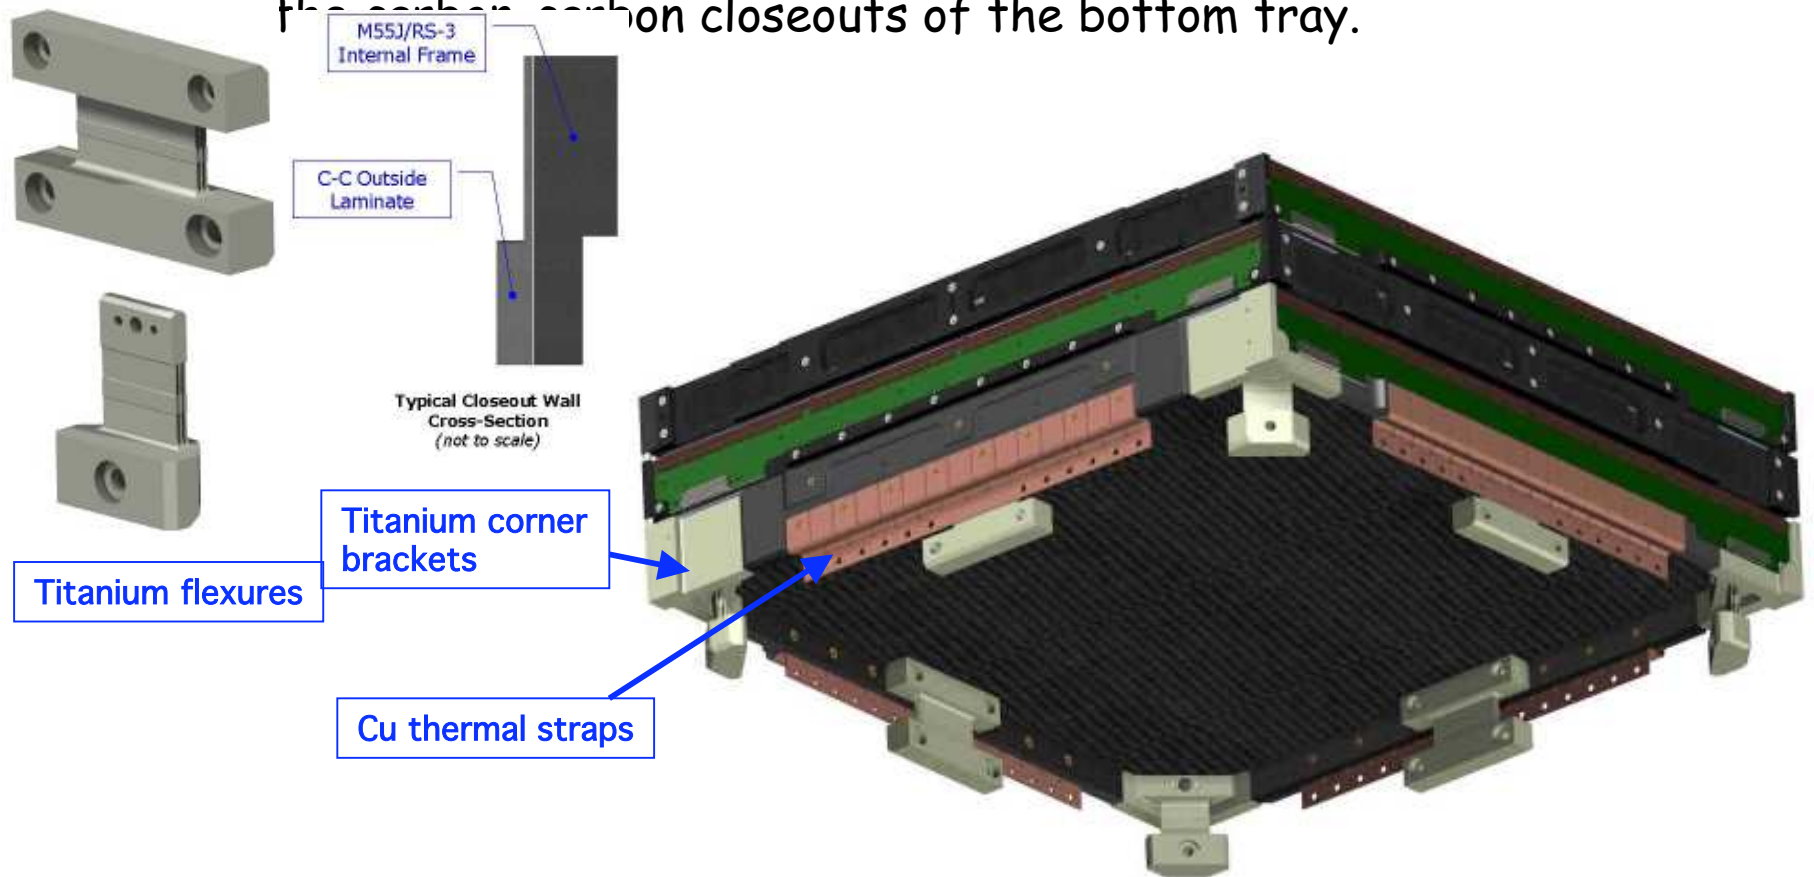
Bottom tray redesign

Close-up view of the interfaces on the bottom of a Tracker module.

This interface has been substantially redesigned since the May '02 random vibration tests of the prototype tower module, during which structural failures of the carbon-carbon closeouts of the bottom tray.

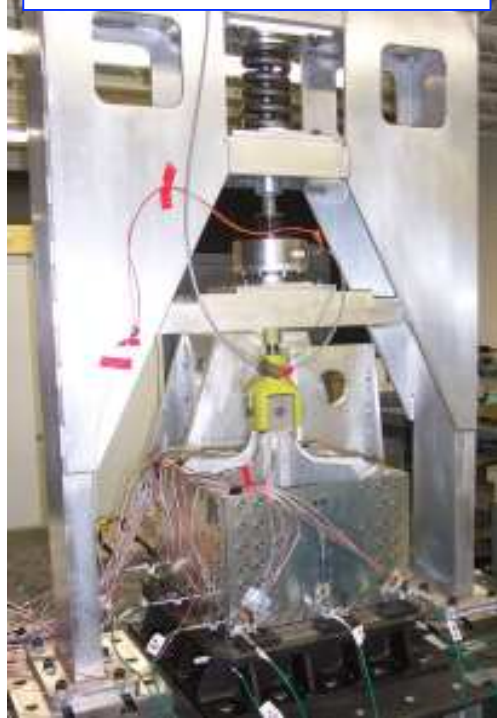
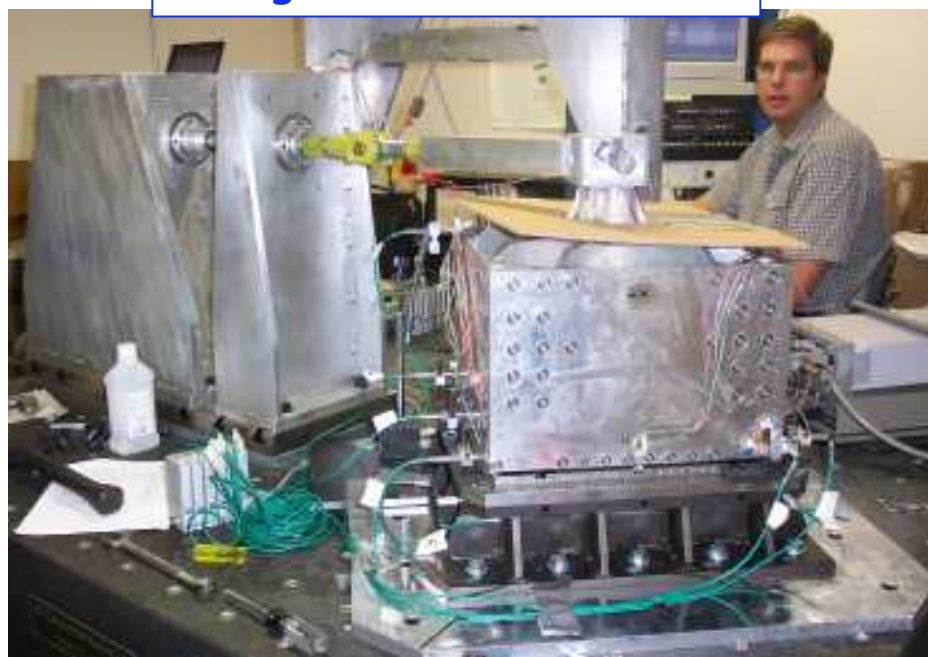
Bottom tray static tests

The static test will be performed on each bottom tray.

The test load on all the axes is equivalent to **3 σ Static Equivalent Random Vibration Loads in tension.**

The **Vertical test setup** tray is going to be tested

Horizontal test setup, 45 $^\circ$ configuration

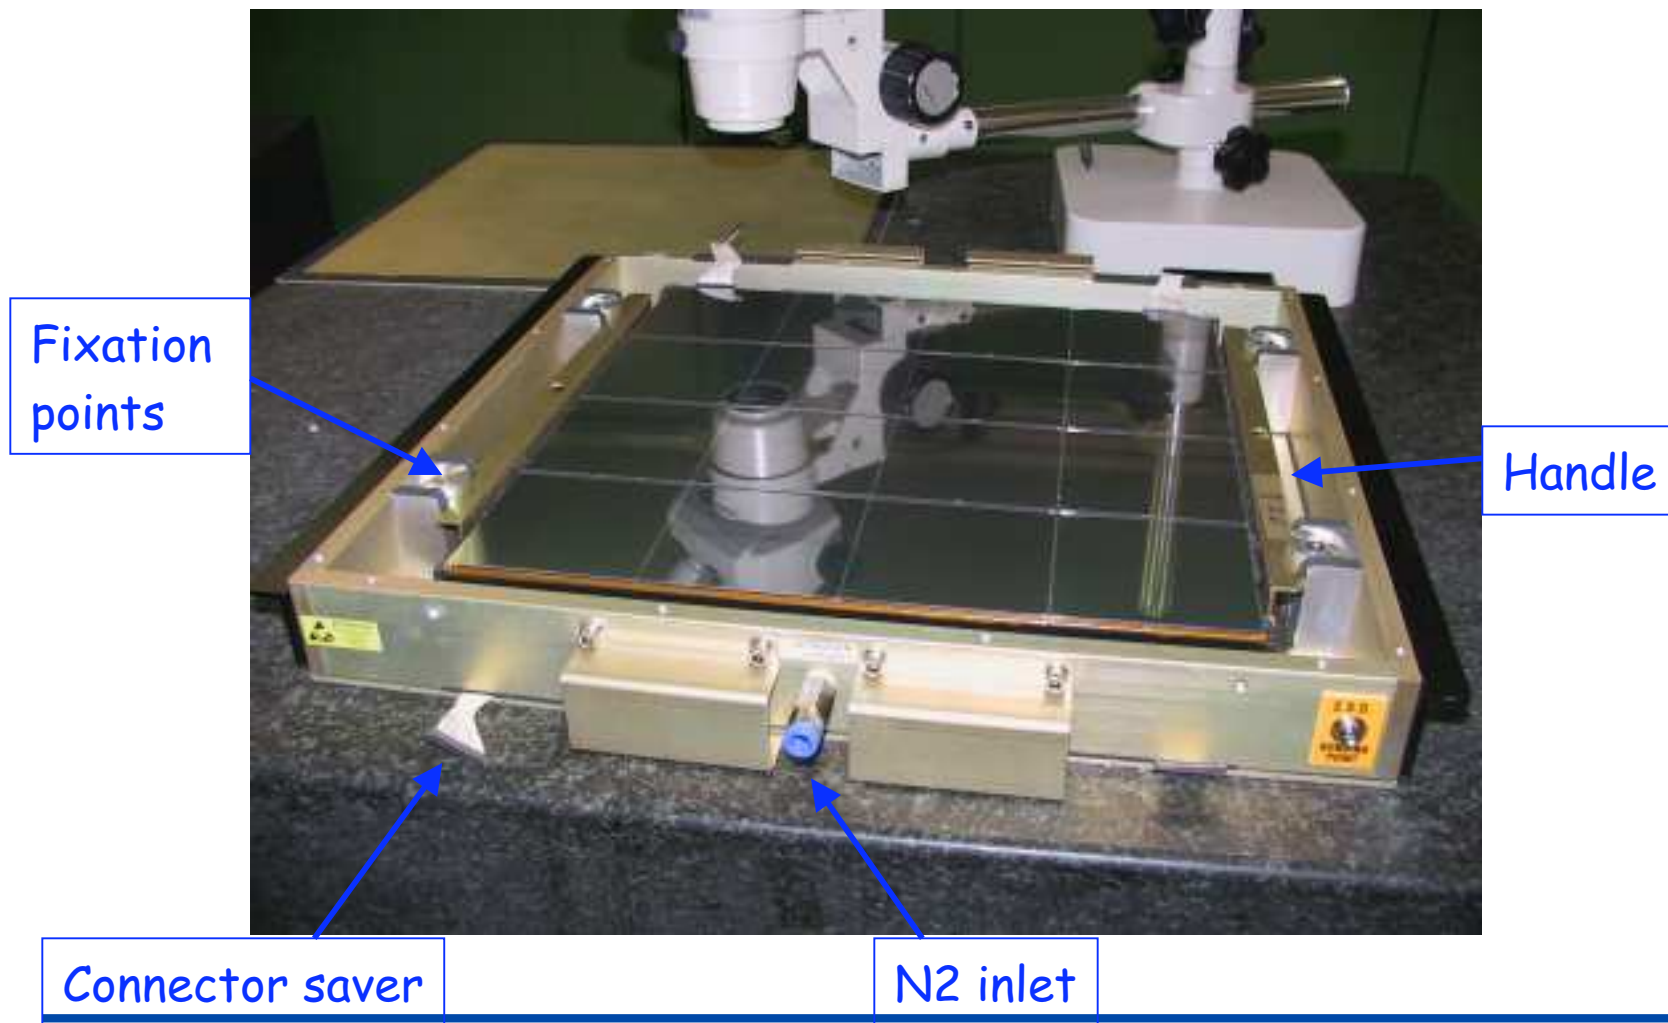
Tray box

The tray box allows safe shipping and storage.
Through the connector savers the tray can be fully tested in the closed box.

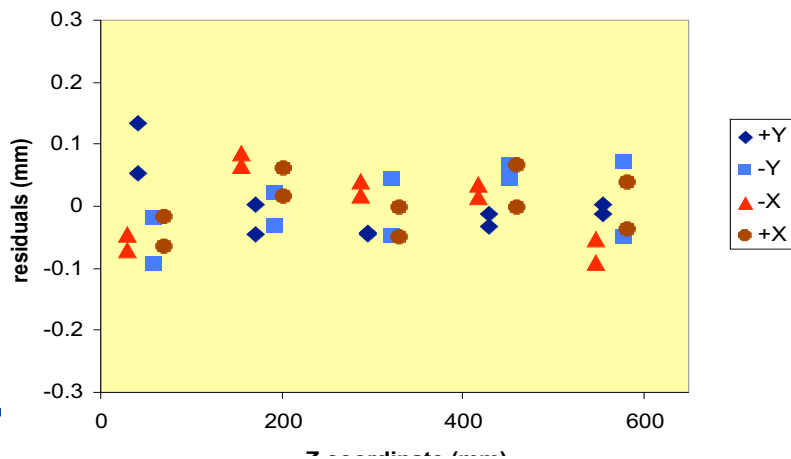
Fixture

residuals from best fit parallelepiped with base 371.3mmX371.2mm

Geometrical tolerances well within limits (0.3 mm).

- Due to a wrong indication in the drawings, the sidewalls were not at specs (2 missing YS90 tissue layers).
- The fixture and the cable holder, 2 interface frames between the shaker and the tower, had constructive problems that could not be worked out. The fixture and the cable holder are now in SLAC for reworking
